# **LOWER GREEN RIVER LEVEE AND REVTMENT REPAIRS**

Construction Years 2001-2003  
Batched Biological Assessment for  
Puget Sound Chinook and Coho Salmon,  
Bull Trout and Bald Eagle

Second Draft Report Prepared by  
King County Department of Natural Resources  
Water and Land Resources Division  
Rivers Section

February, 2001

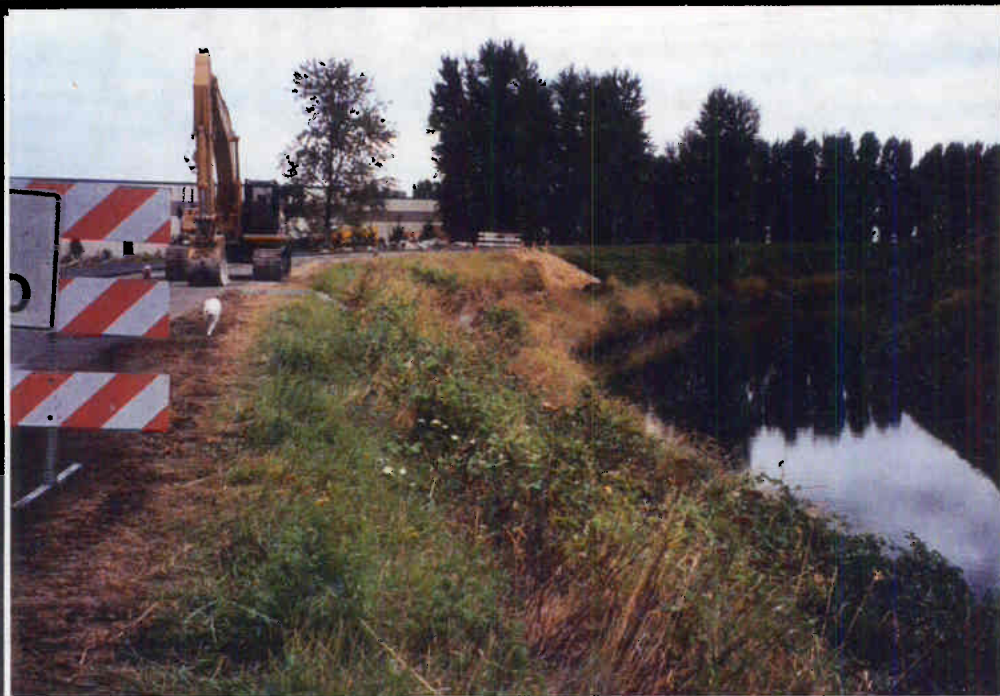
Appendix C-B2. Desimone Levee Repair. Levee face prior to bench excavation.  
Aspect = south (looking upstream); September, 1999.

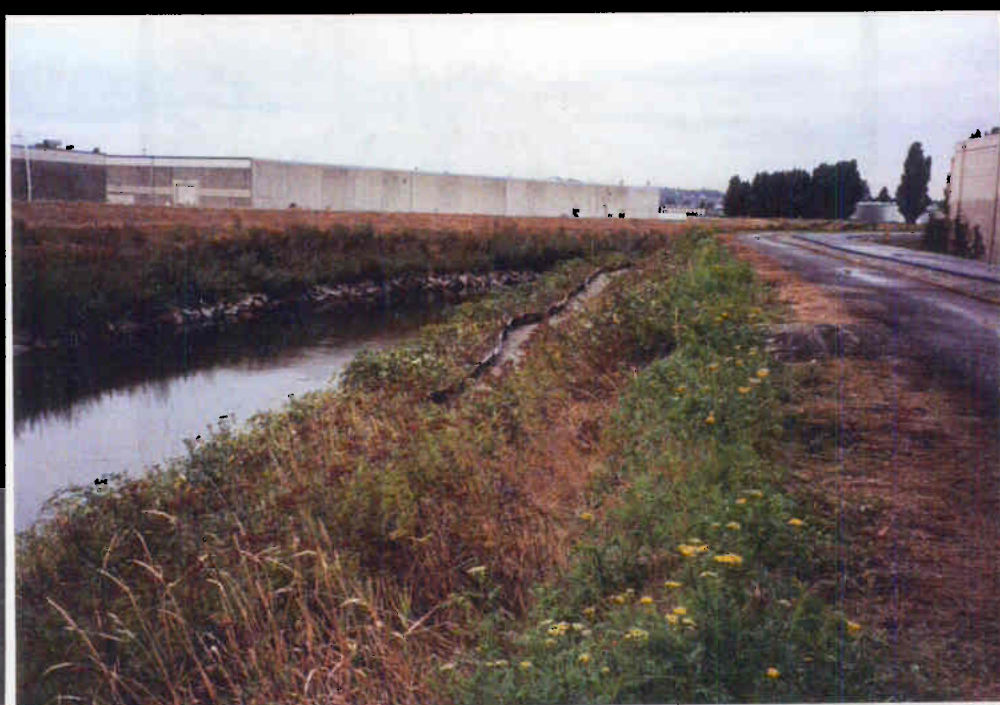
Appendix C-B3. Desimone Levee Repair. Levee face prior to bench excavation.  
Aspect = north (looking downstream); September, 1999.

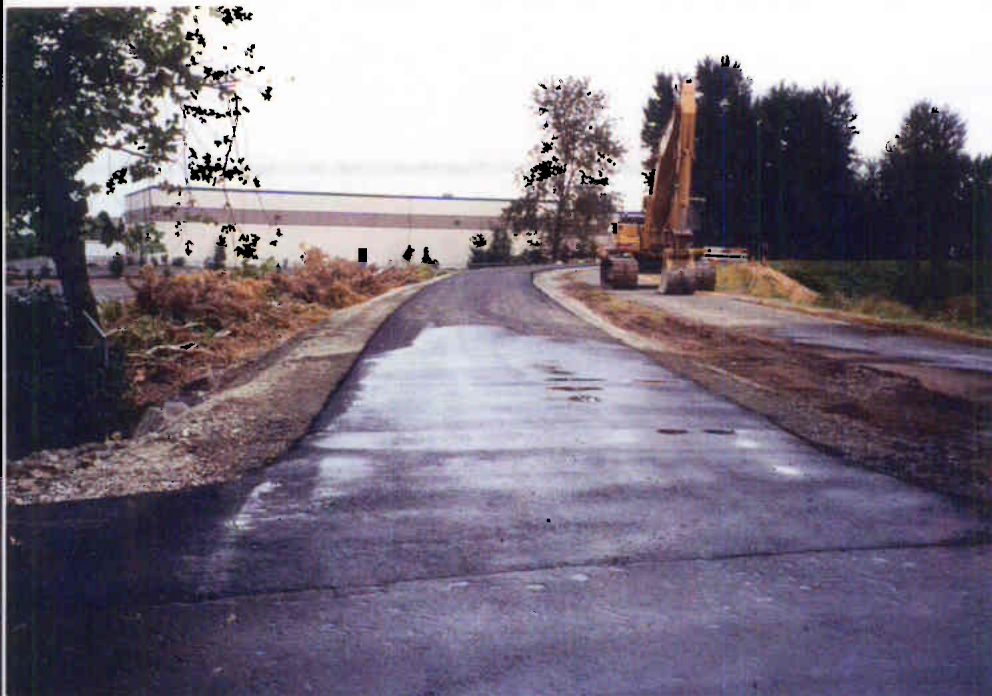
Appendix C-B4. Desimone Levee Repair. Levee crest prior to bench creation. Aspect = south (looking upstream); September, 1999.

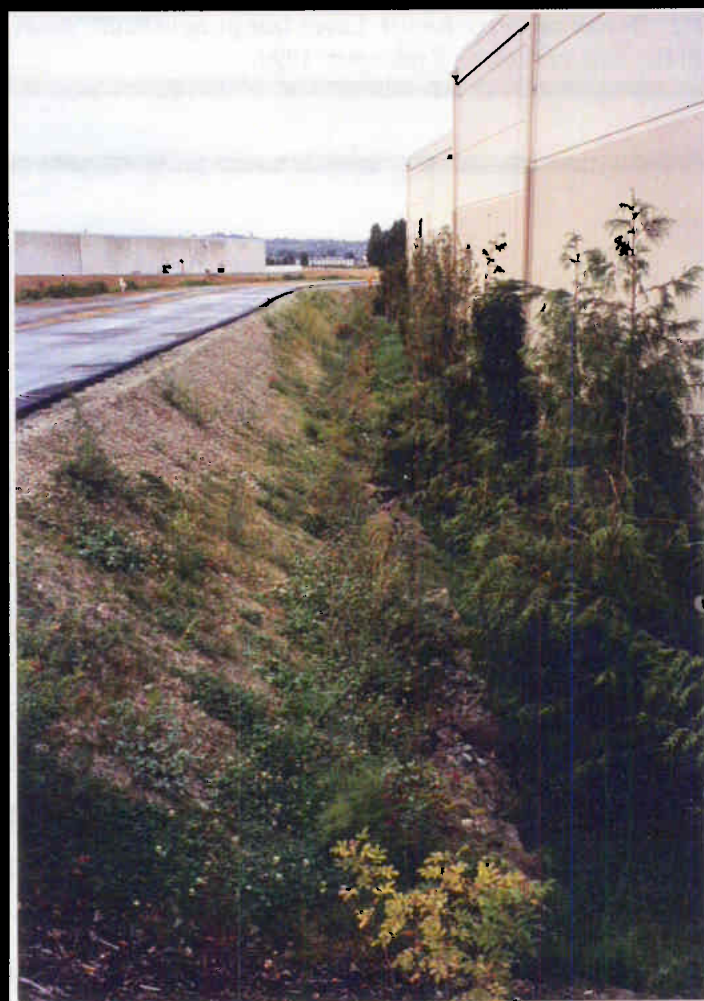
Figure C-B5. Desimone Levee Repair. Levee backslope vegetation planted during 1998-1999 plant dormancy season. Aspect = north; September, 1999.

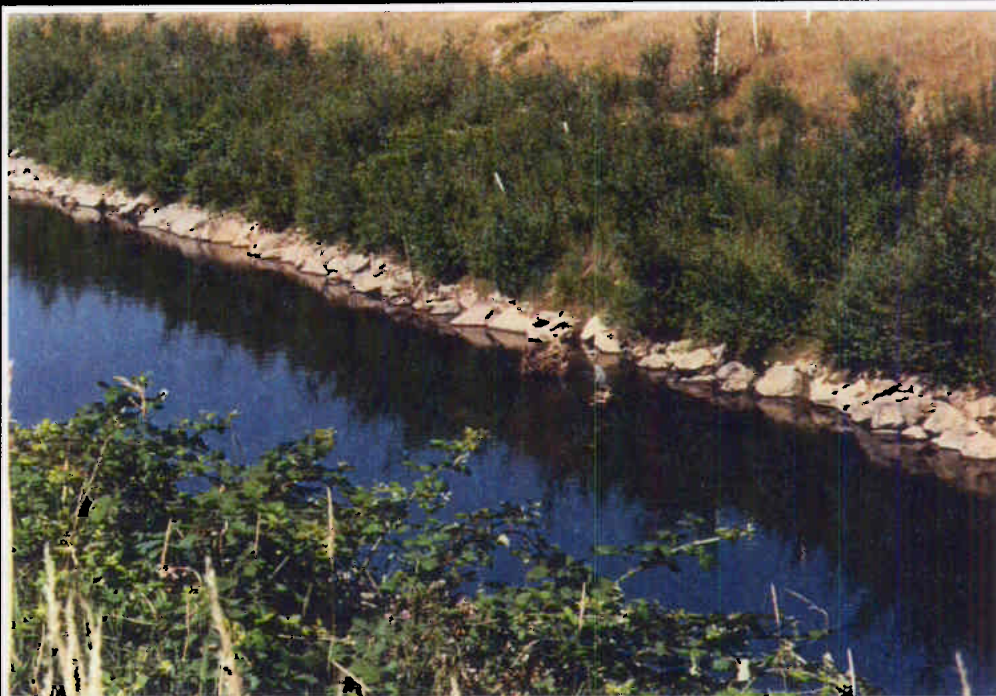
Appendix C-A2. Segale Levee Repair. Willows and LWD installed during the 1996 repair project (just upstream from 2000 project). Aspect = southwest; July, 1999.

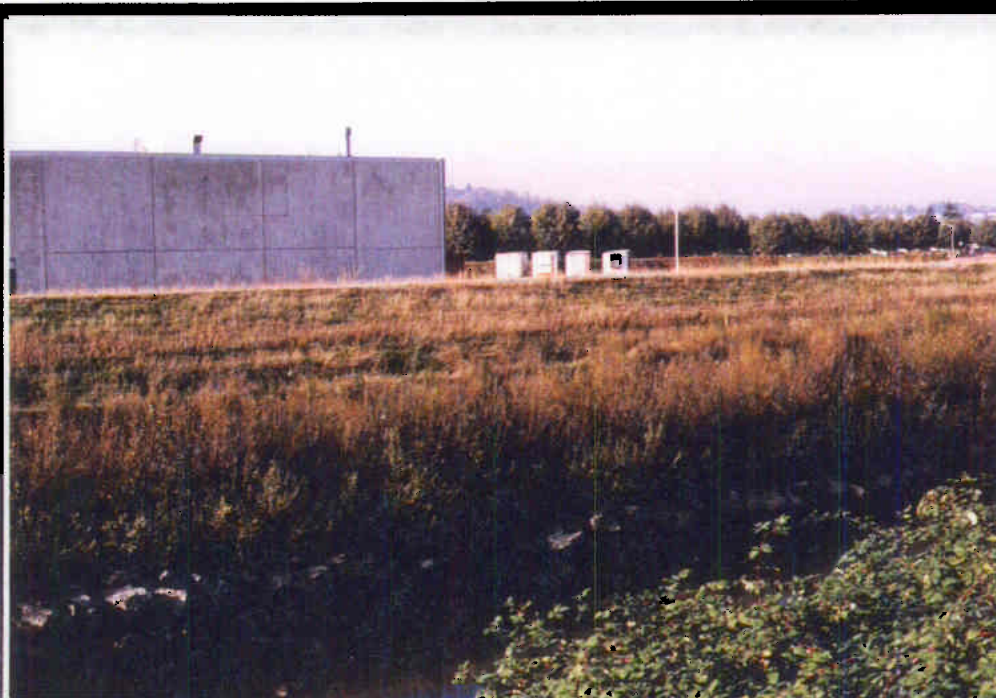
Appendix C-A3. Segale Levee Repair. Missing toe rock to be replaced with addition of LWD in 2000. Aspect = west; October, 1997.

Segale Levee Repair: Since the 1996 *in situ* repairs shown in Figure 3.2 were conducted toe rock has become dislocated in patches over approximately 175 lineal feet of this earlier repair, due to shifting of the sandy river bed and undercutting erosion. Because lower and middle bank zones above the missing toe rock are thoroughly revegetated with willow layers that could be lost if undercutting proceeds further, a decision was made to restore the toe in a manner that provides substantially greater volumes of LWD while avoiding wholesale disturbance of the willows and upper bank.

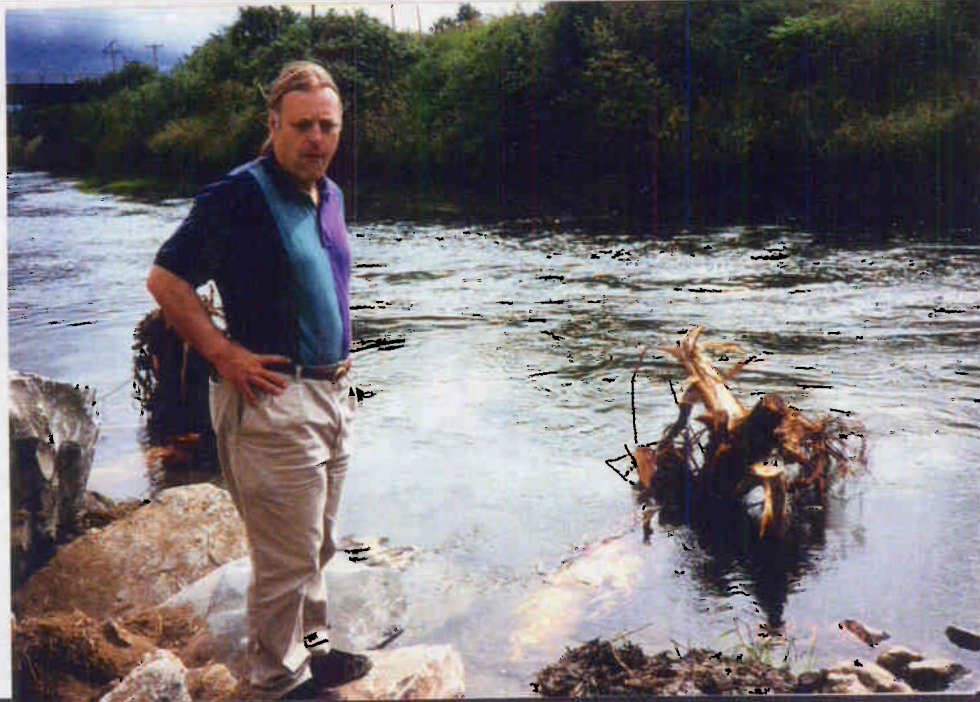
Appendix C-C2. Boeing Revetment Repair. Toe rock and logs installed during 1996 repair (just upstream from present repair). Aspect = southwest; June, 1996.

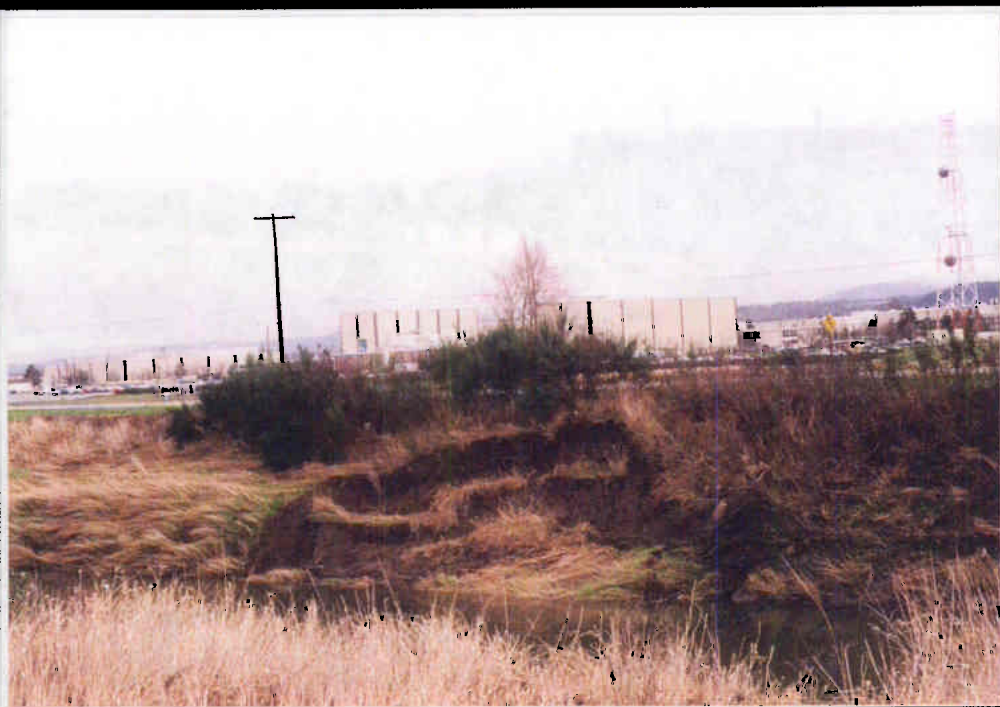
Appendix C-C3. Boeing Revetment Repair. Slump at 2000 repair site. Aspect = east; September, 1999.

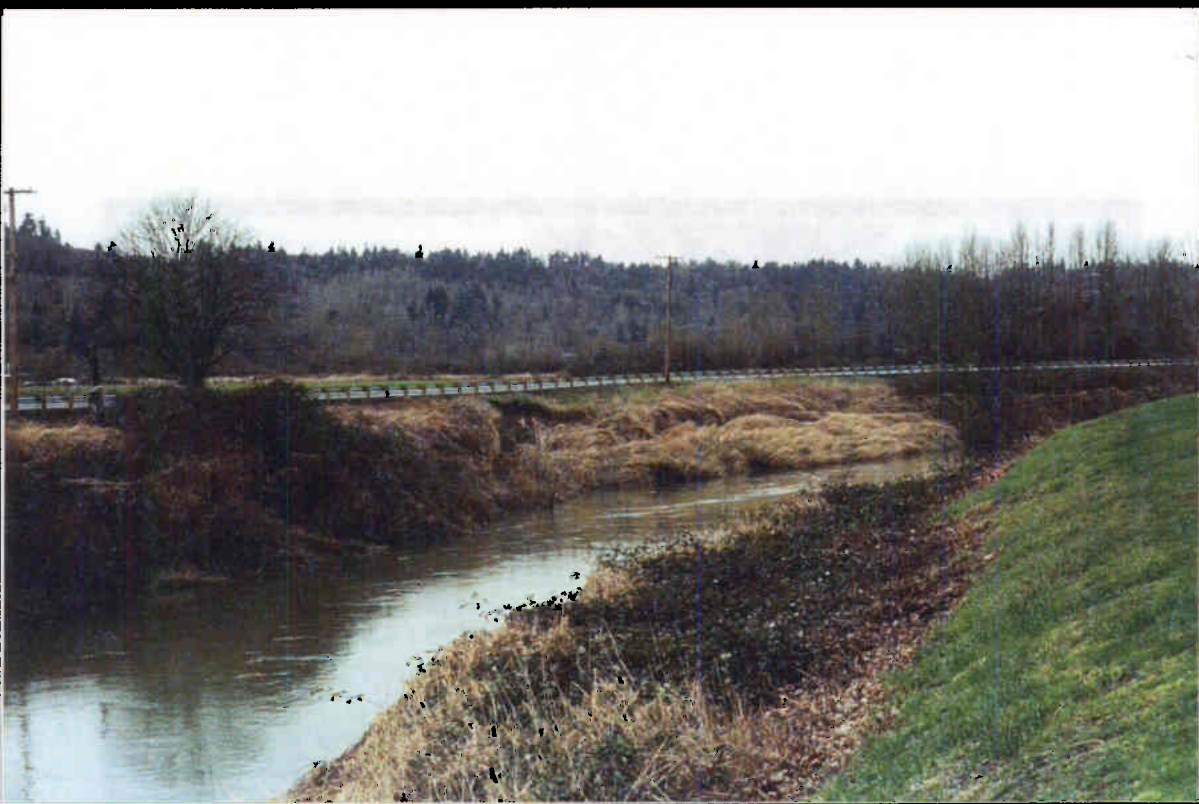
Appendix C-D2. Frager Road Revetment Repair. Lateral scour pool beneath slump. Aspect = northwest (looking downstream); September, 1999.

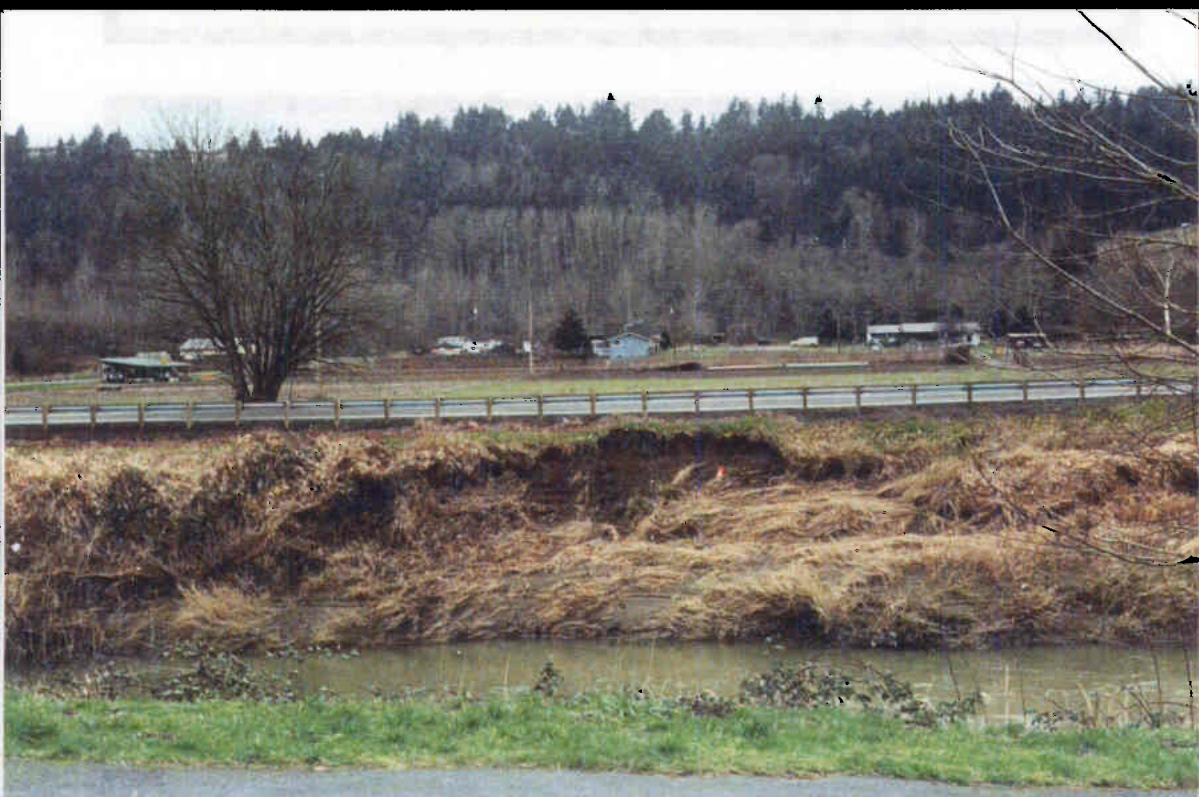
Appendix C-D3. Frager Road Revetment Repair. Slump at 2000 repair site. Aspect = west; September, 1999.

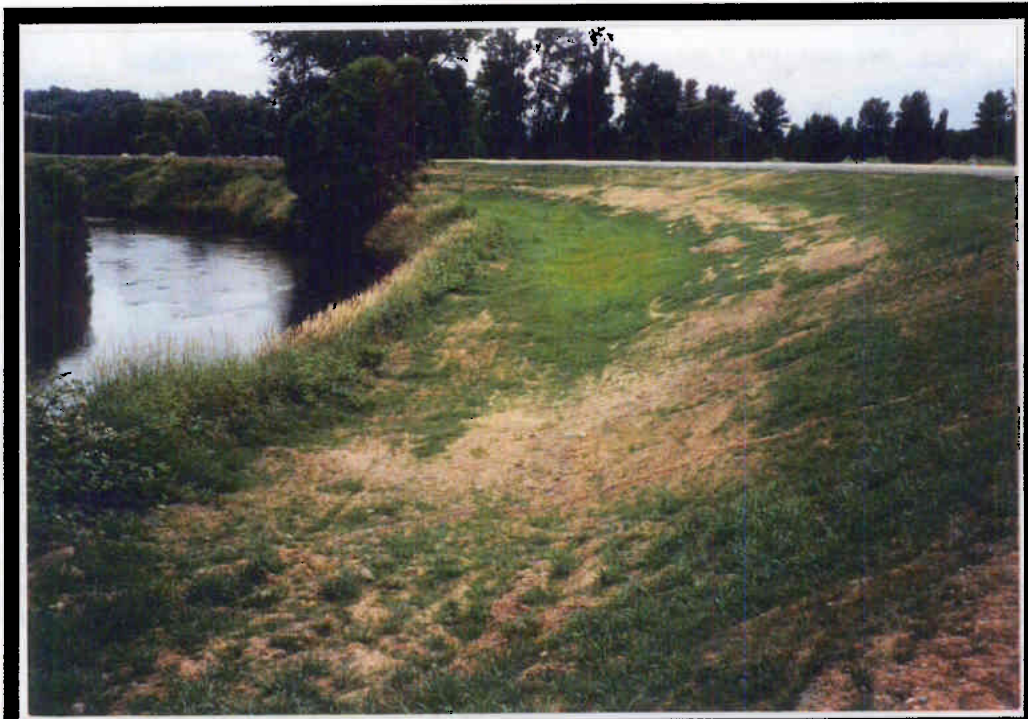
Appendix C-E2. Narita Levee Repair. Mid-slope bench excavated in April, 1999.  
Aspect = north (looking downstream); July, 1999.

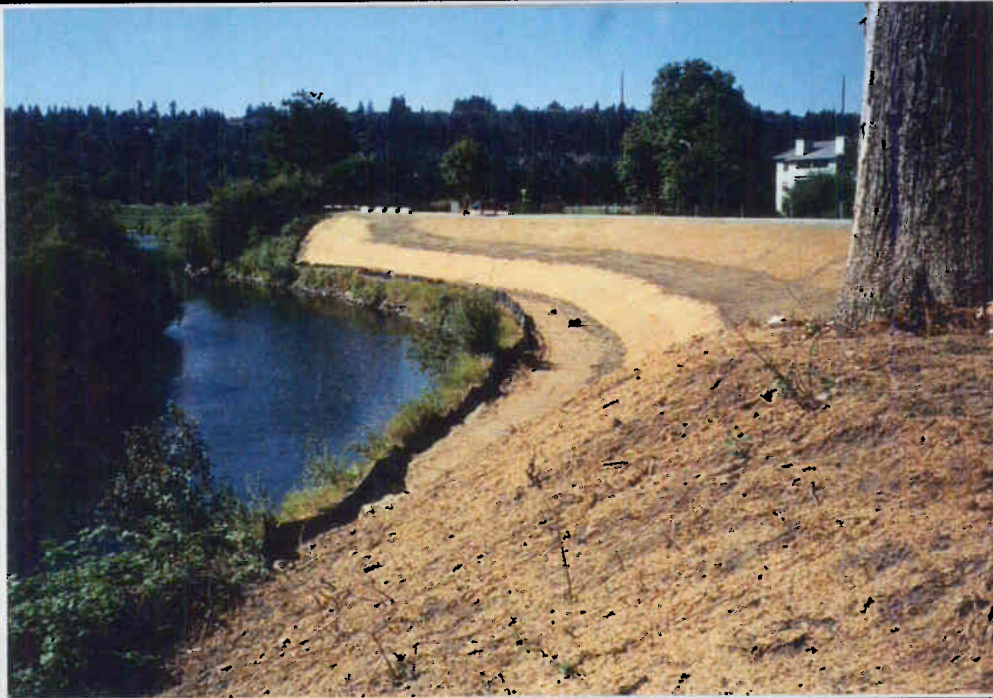
Appendix C-F2. Pipeline Levee Repair. Levee face following 1999 low bench excavation. Aspect = south (looking downstream); August, 1999.

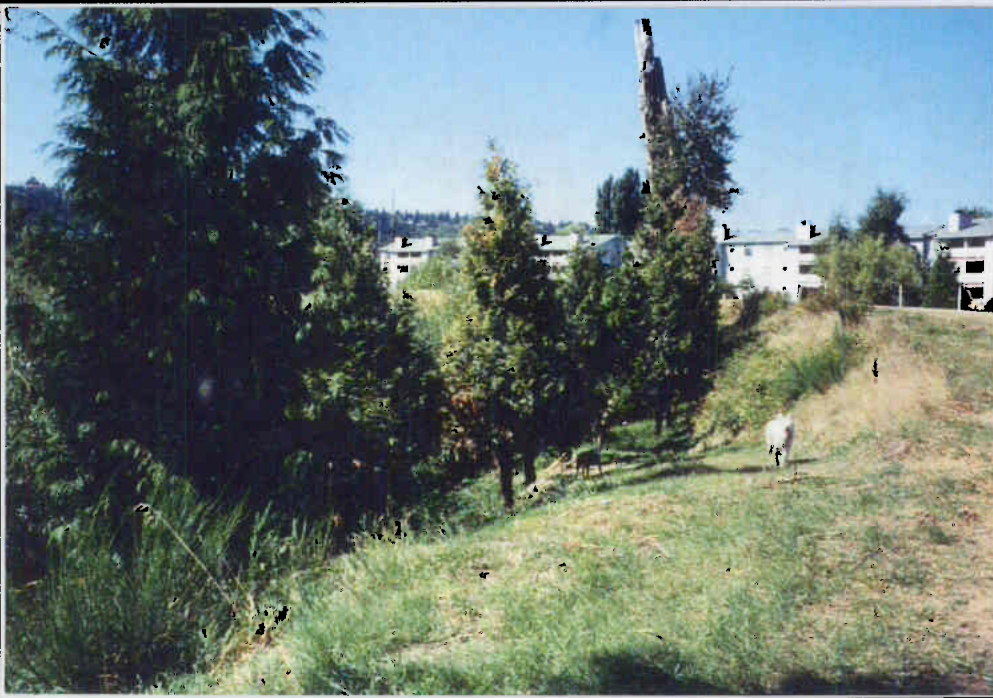
Appendix C-F3. Pipeline Levee Repair. Trees relocated from Pipeline to Okimoto Revetment just upstream. Aspect = south (looking downstream); August, 1999.

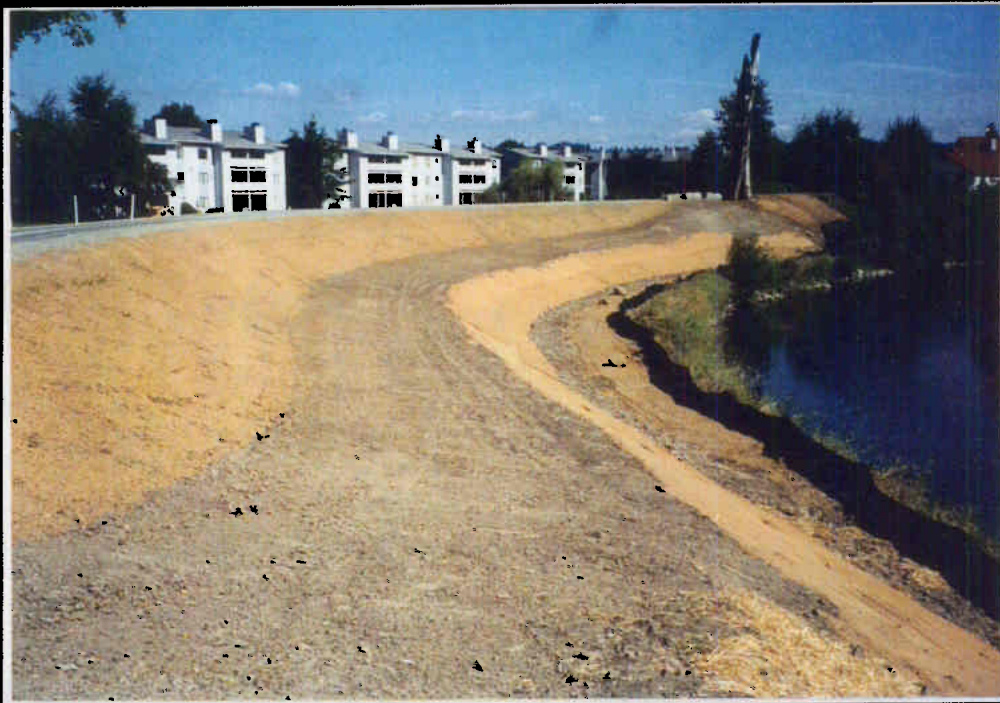
Appendix C-F4. Pipeline Levee Repair. Levee face following 1999 low bench excavation. Aspect = north (looking upstream); August, 1999.

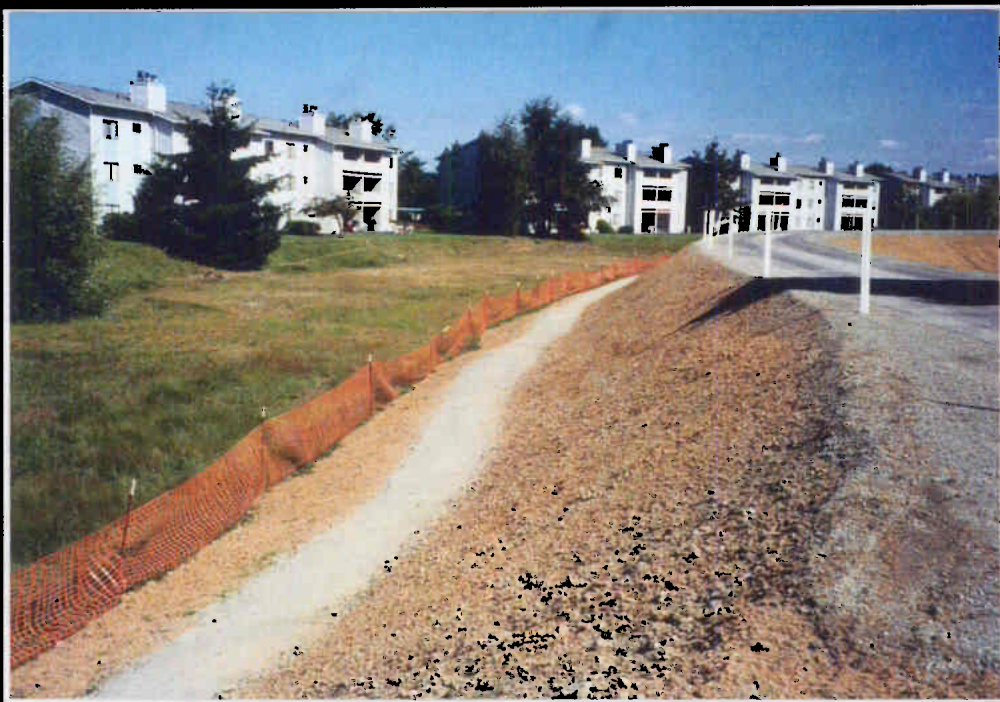
Appendix C-F5. Pipeline Levee Repair. Levee backslope following 1999 low bench excavation. Aspect = north (looking upstream); August, 1999.

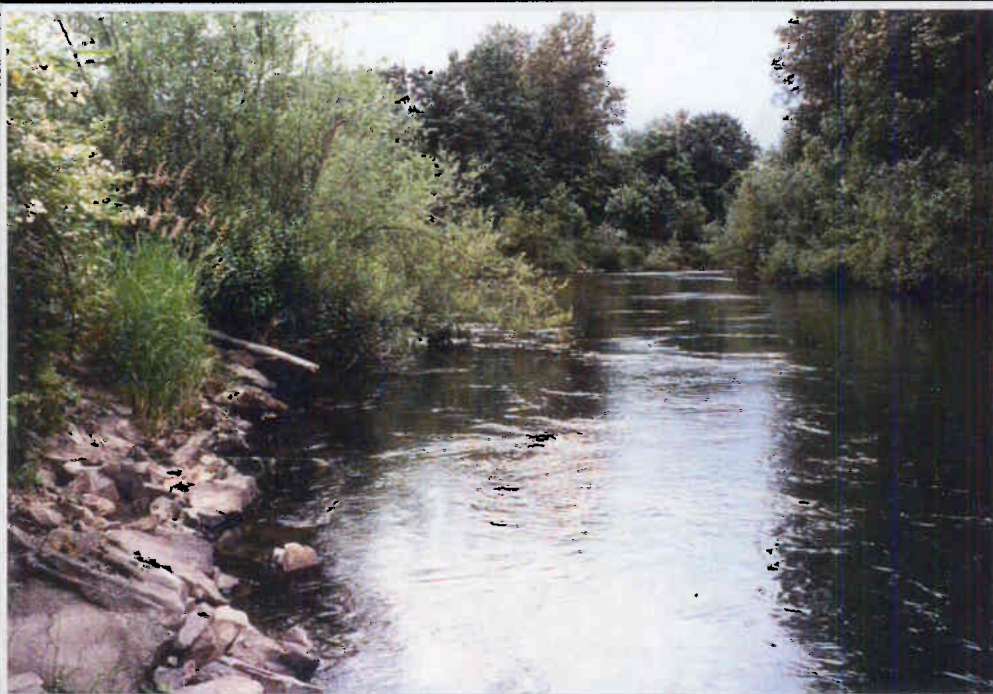
Appendix C-G2. Fenster Revetment Repair. Revetment face. Aspect = west (looking downstream); July, 1999.

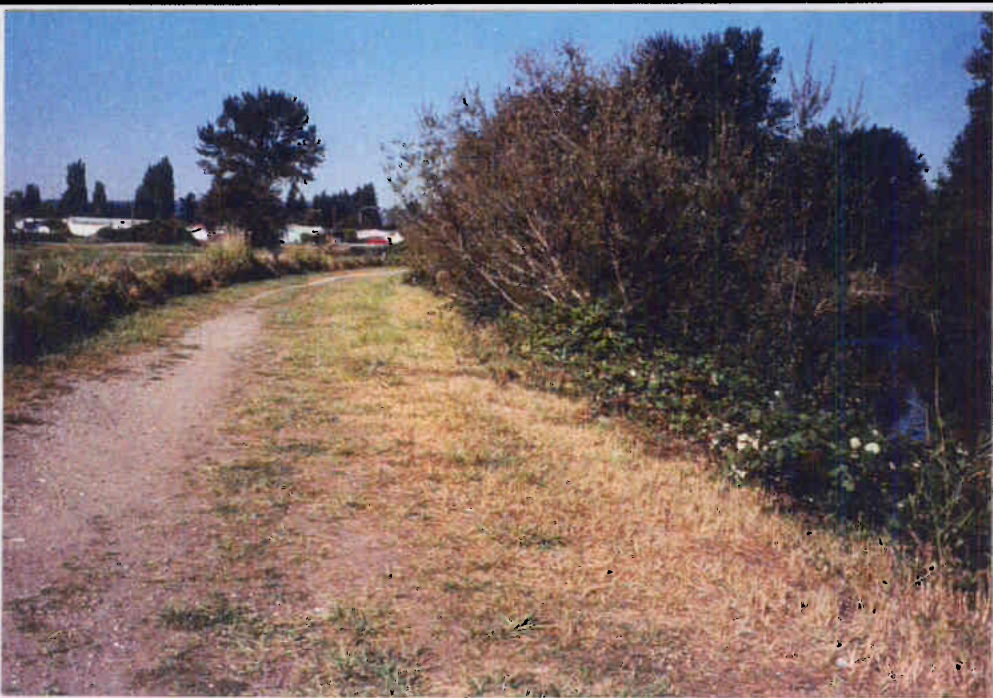
Appendix C-G3. Fenster Revetment Repair. Revetment crest. Aspect = west (looking downstream); July, 1999.
